**Citation:** Gucunski, N., Slabaugh, G. G., Wang, Z., Fang, T. & Maher, A. (2008). Impact echo data from bridge deck testing: Visualization and interpretation. *Transportation Research Record*(2050), pp. 111-121. doi: 10.3141/2050-11

## **VISUALIZATION AND INTERPRETATION OF IMPACT ECHO DATA FROM BRIDGE DECK TESTING**

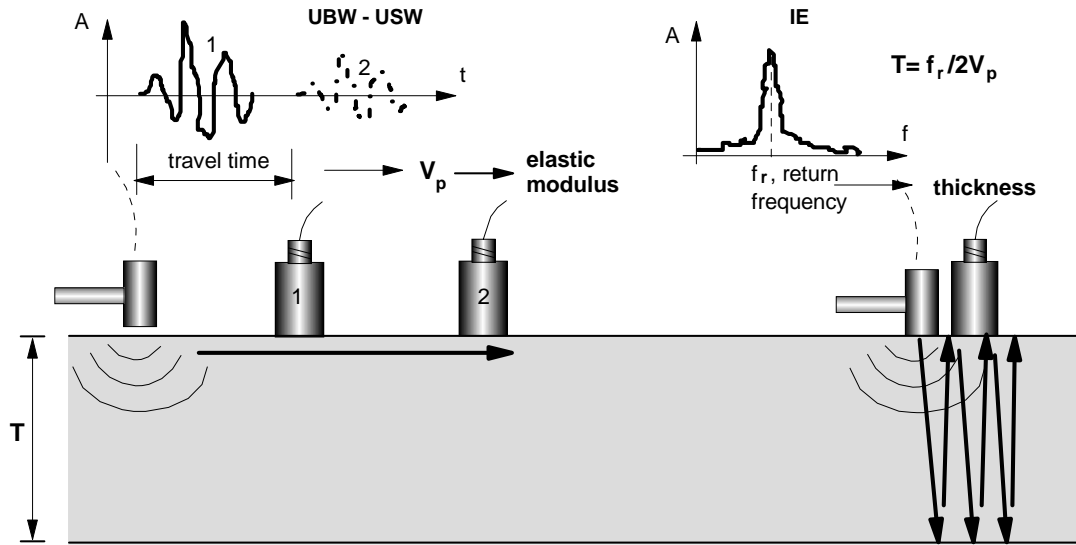
Application of UBW, USW and IE techniques in the evaluation of a bridge deck is illustrated in Figure 1. In the first part of the evaluation, the UBW and USW tests are conducted using an impact source and two receivers. The UBW technique is used to measure the velocity of propagation of compression (P) waves. By measuring the travel time of the P-wave between two receivers, the first wave arrivals, the P-wave velocity ( $V_p$ ) is calculated. Because it is often difficult to identify P-wave arrivals in an automated way, a more reliable procedure to estimate the P-wave velocity is through a measurement of the surface (Rayleigh or R) wave velocity using the USW test. The USW test is identical to the SASW test (7,8), except that the frequency range of interest is limited to a narrow high frequency range where the velocity of the surface wave (phase velocity) does not vary significantly with frequency (9). Variation in the phase velocity would be an indication of variation of material properties (elastic moduli) with depth. Once the R-wave velocity is determined, it can be well correlated to both compression and shear (S) wave velocities, and thus to the Young's and shear moduli. In the second part of the evaluation, the IE test is conducted using an impact source and a single nearby receiver. Because of a significant contrast in rigidity of concrete and air, the elastic wave is practically entirely reflected off the bottom of the deck back to the deck surface. The frequency of the reflection, called return frequency, can be identified in the response spectrum of the recorded signal. Finally, the depth of the reflector, in this case the deck thickness, can be obtained from the return frequency and the previously determined P-wave velocity, as illustrated in Figure 1.

**FIGURE 1** Measurement of bridge deck elastic modulus and thickness by UBW and IE methods.

While the primary objective of IE testing is to determine dominant reflectors, according to the relationship described in Figure 1, a unique thickness or depth of the reflector can be correlated to every component of the frequency spectrum. This is illustrated in Figure 2 by a frequency spectrum, and the corresponding thickness spectrum. The thickness spectrum enables simple data interpretation, because positions of the dominant and secondary peaks describe clearly the pattern of energy partitioning, and thus the degree of delamination. Spectra for a set of points along a single test line can be combined to form spectral surfaces. As shown in the same figure, frequency spectra for one test line on a bridge deck are combined to form a frequency spectral surface and are converted into a corresponding thickness spectral surface. The following observations, regarding the advantages of the two surface types, can be made when linear scales are used for both frequencies and depths. The frequency spectral surface

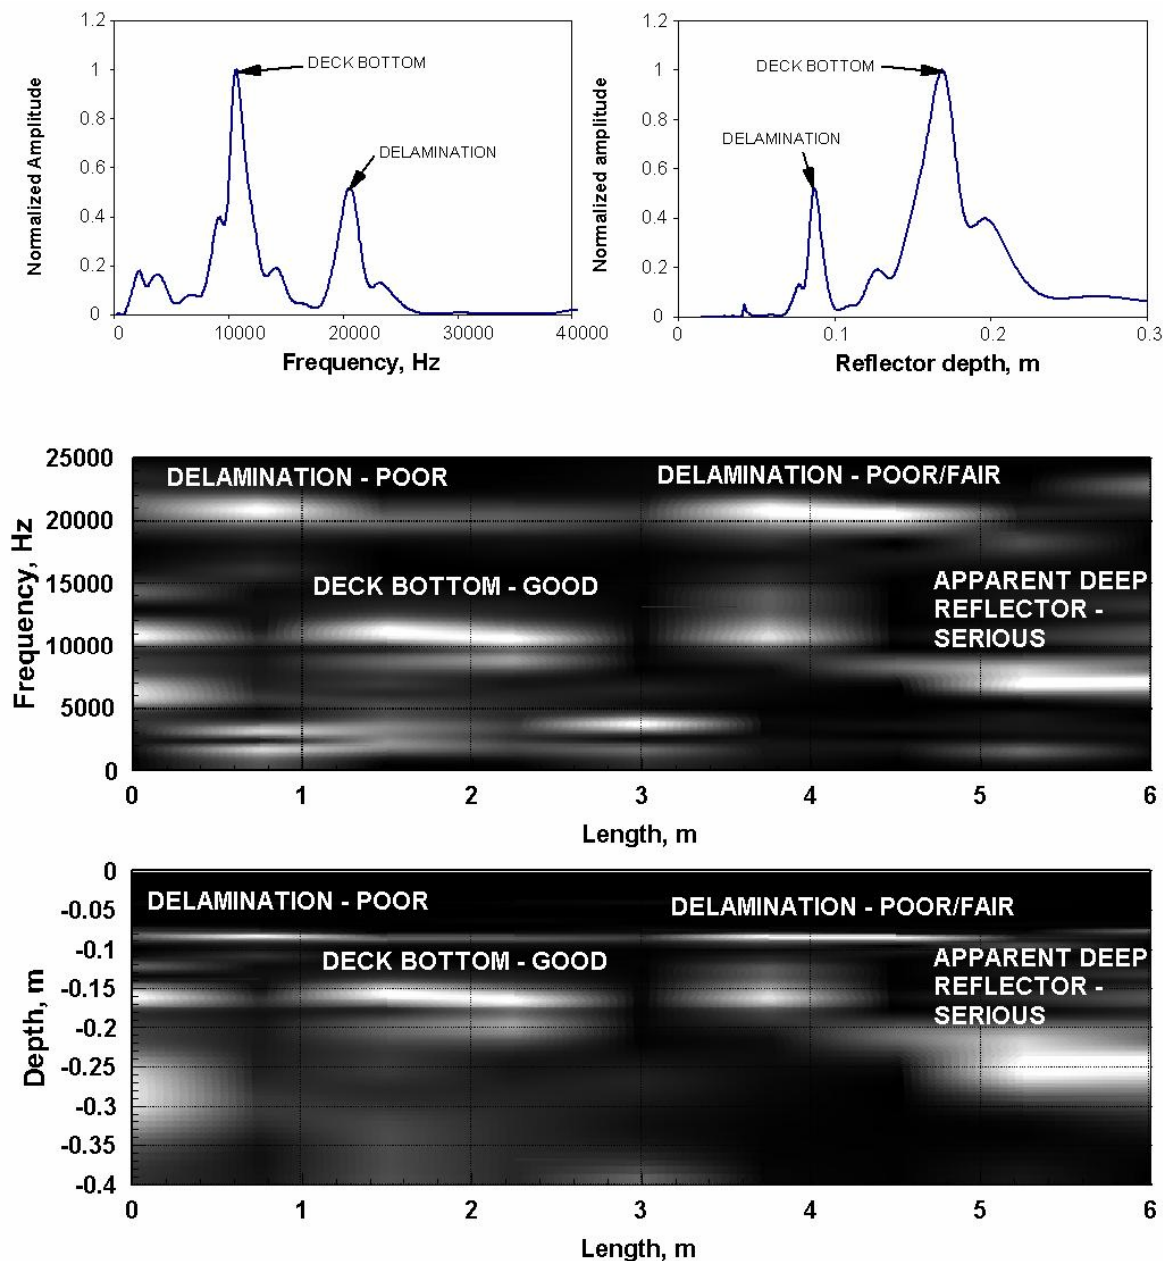
emphasizes presence of shallow delaminations, while the thickness spectrum emphasizes presence of apparent deep reflectors, deck zones in a serious condition that will be discussed in the following section (10). Because the thickness spectral surface represents a more natural choice for data viewing, a properly selected nonlinear depth scale can provide a well-balanced image for identification of all detected reflectors.

**FIGURE 2** Frequency and thickness spectra and spectral surfaces.

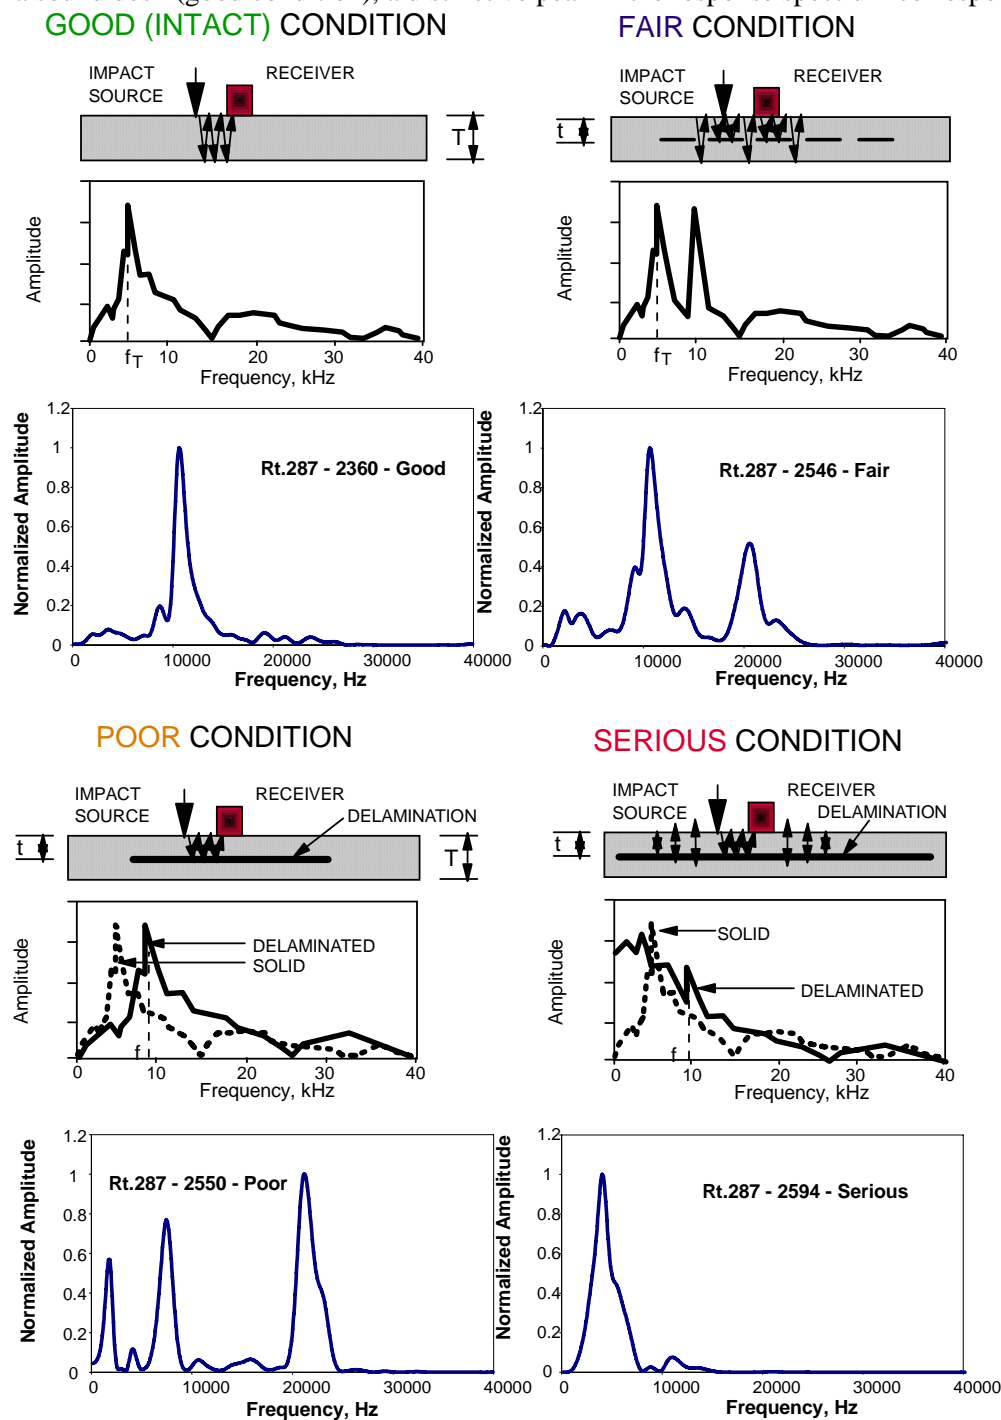
In the case of a delaminated deck, reflections of the P-wave occur at shallower depths, causing a shift in the response spectrum towards higher frequencies. Depending on the extent and continuity of the delamination, the partitioning of energy of elastic waves may vary and different grades can be assigned to

that particular section of a deck as a part of the condition assessment process. This is illustrated in Figure 3. In the case of a sound deck (good condition), a distinctive peak in the response spectrum corresponding

**FIGURE 3** Grades for various degrees of deck delamination.

to the full depth of the deck, can be observed. This is illustrated by two spectra under the schematic of the bridge deck. The upper spectrum in the figure represents a schematic of the expected spectrum, while the lower spectrum is taken from actual field testing. Initial delamination (fair condition) is described as occasional separations between the two deck zones. It can be identified through the presence of two

distinct peaks, indicating energy partitioning from two dominant wave propagation patterns. The first peak corresponds to reflections from the bottom of the deck, while the second corresponds to reflections from the delamination. Progressed delamination (poor condition) is characterized by a single peak at a frequency corresponding to a reflector depth that is shallower than the deck thickness, indicating that little or no energy is being propagated towards the bottom of the deck. Finally, in a very severe case of a wide delamination (serious condition), the dominant response of the deck to an impact is characterized by a low frequency response of flexural mode oscillations of the upper delaminated portion of the deck. This response is almost always in the audible frequency range, unlike response of the deck in the fair and poor condition that may be in the ultrasonic range. Because it is significantly lower than the return frequency for the deck bottom, it produces an apparent reflector depth that is larger than the deck thickness.

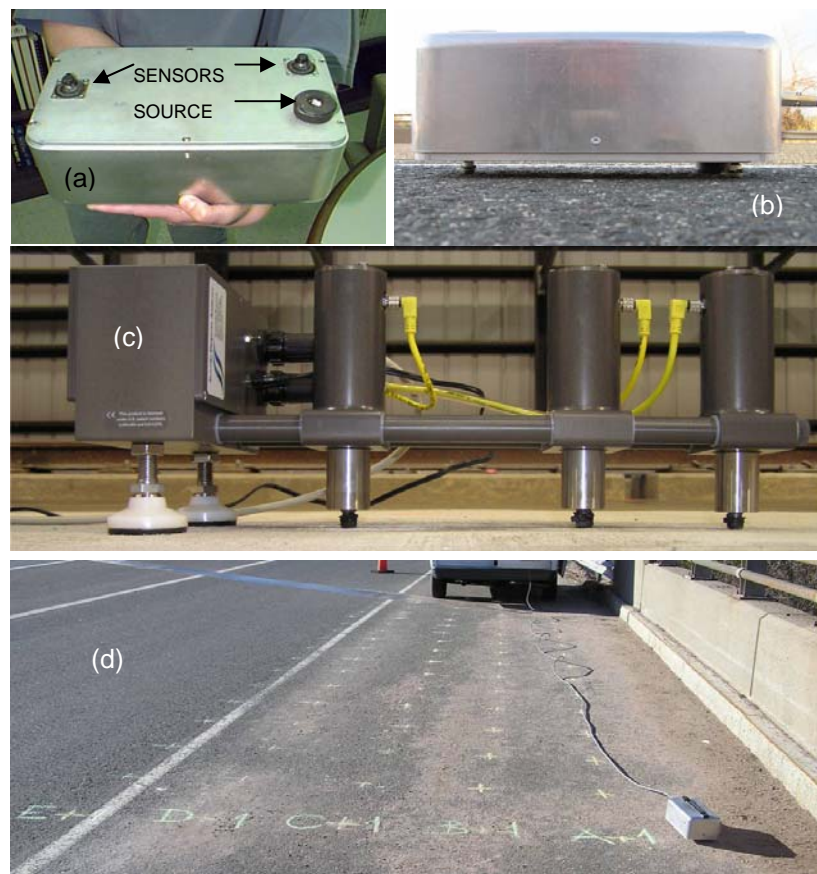
IE is commonly implemented in deck evaluations by conducting point testing on a grid of selected spacing. The testing is conducted using impact echo devices, which in some case integrate other ultrasonic seismic methods. One of such devices is PSPA with has a sole purpose of evaluation of surface pavement layers and bridge decks. The device integrates all three previously described ultrasonic techniques (UBW, USW, IE). The core of the PSPA system is a sensor box (Figure 4a), a box containing a solenoid type impact hammer and two high frequency accelerometers, 7.5 and 21.5 cm away from the hammer. All controls and data acquisition are in a computer that is connected by a serial cable to the sensor box. A new design of the PSPA (Figure 4c) has all data acquisition and control elements are a part of the unit. Field evaluation of bridge decks is typically done on grids of 0.6x0.6 m to 0.9x0.9 m (Figure

**FIGURE 4** Older and newer versions of PSPA sensor box (a and c), and field implementation (b and d).

4d). Testing using the PSPA is simple and for a single point takes less than 30 seconds. The sensor box is placed at the test point (Figure 4c), a series of impacts (6-10) of 50  $\mu$ s duration are applied and acceleration histories are recorded. The testing is fairly insensitive to traffic induced vibrations because of the high frequency range used—typically between 2 and 30 kHz.

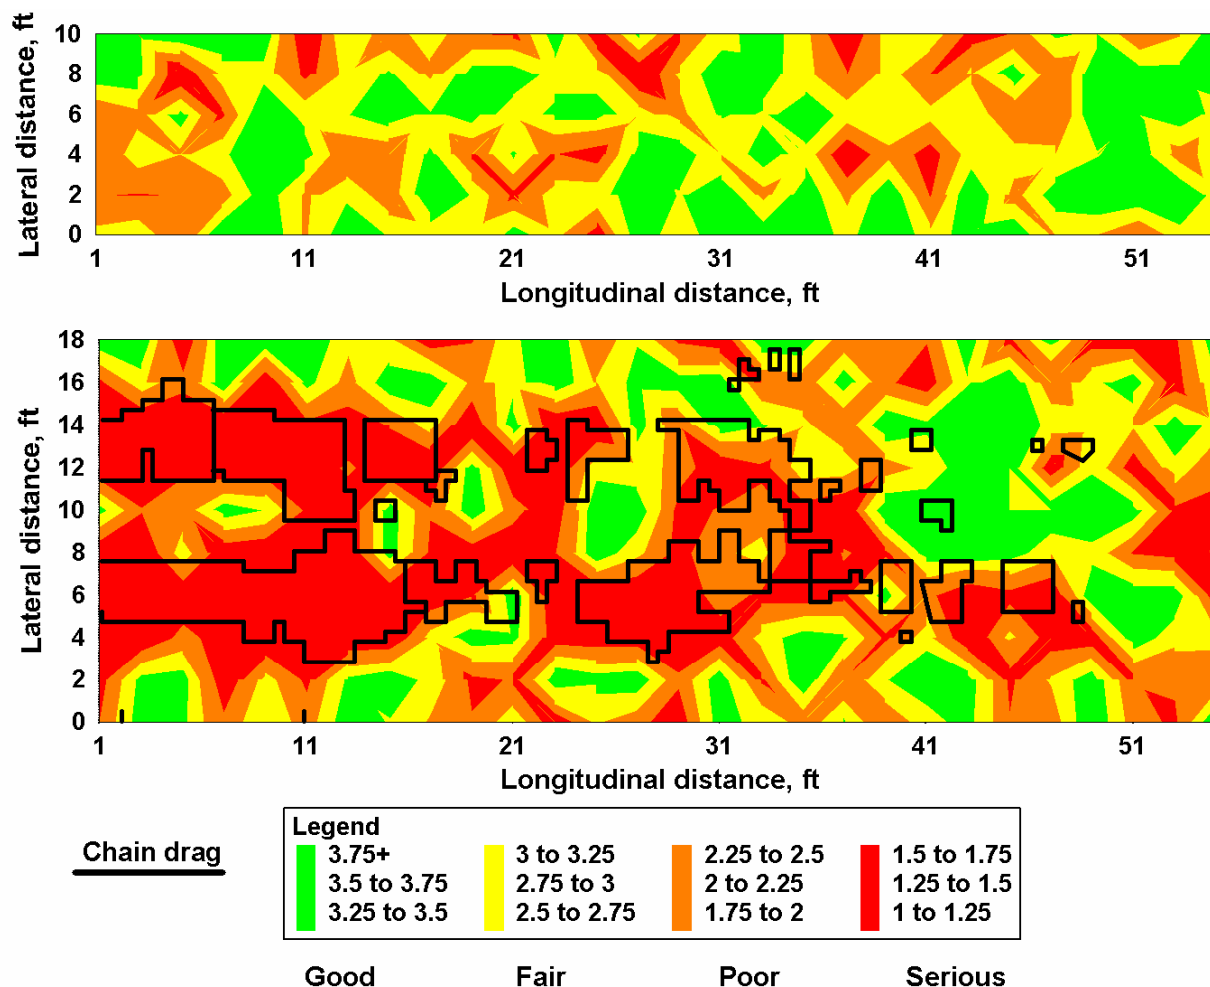
**FIGURE 5** Condition assessment maps for Carter Creek Bridge (top) and Van Buren Bridge (bottom).

PSPA testing results are commonly described in terms of shear and Young's moduli (or P- and S-wave velocity) distributions, and condition assessment distributions (with respect to the degree of delamination). This is illustrated by conditions maps for sections of two bridges in Virginia, Carter Creek and Van Buren bridges (Figure 5). As can be observed in the upper condition assessment plot for the Carter Creek bridge, the deck is in a good condition and only smaller zones of initial and progressed delamination, and minor zones of a deck in a serious condition, can be identified. On the other hand, the bottom condition assessment plot for Van Buren bridge deck illustrates a deck in a significantly deteriorated condition. Zones of all previously described conditions (grades) can be identified in the condition assessment plot. Since the deck was also evaluated by chain dragging, the PSPA results were compared to those of the chain dragging. The comparison points to similarity of the two approaches in detection of areas with progressed delamination (poor to serious condition). The ability of the chain drag to identify zones in a serious condition can be explained by the fact that the frequency response in such cases is in the audible range. On the other hand, the most of the zones identified by the PSPA as zones of initial delamination (fair to poor grades) were not detected by the chain drag. This ability to detect signs

of initial delamination represents a significant advantage of the PSPA device (seismic ultrasonic testing) over the chain drag approach. It allows more accurate definition of boundaries of delaminated zones, better prediction of delamination progression, and leads to better assessment and timing for implementation of rehabilitation measures.

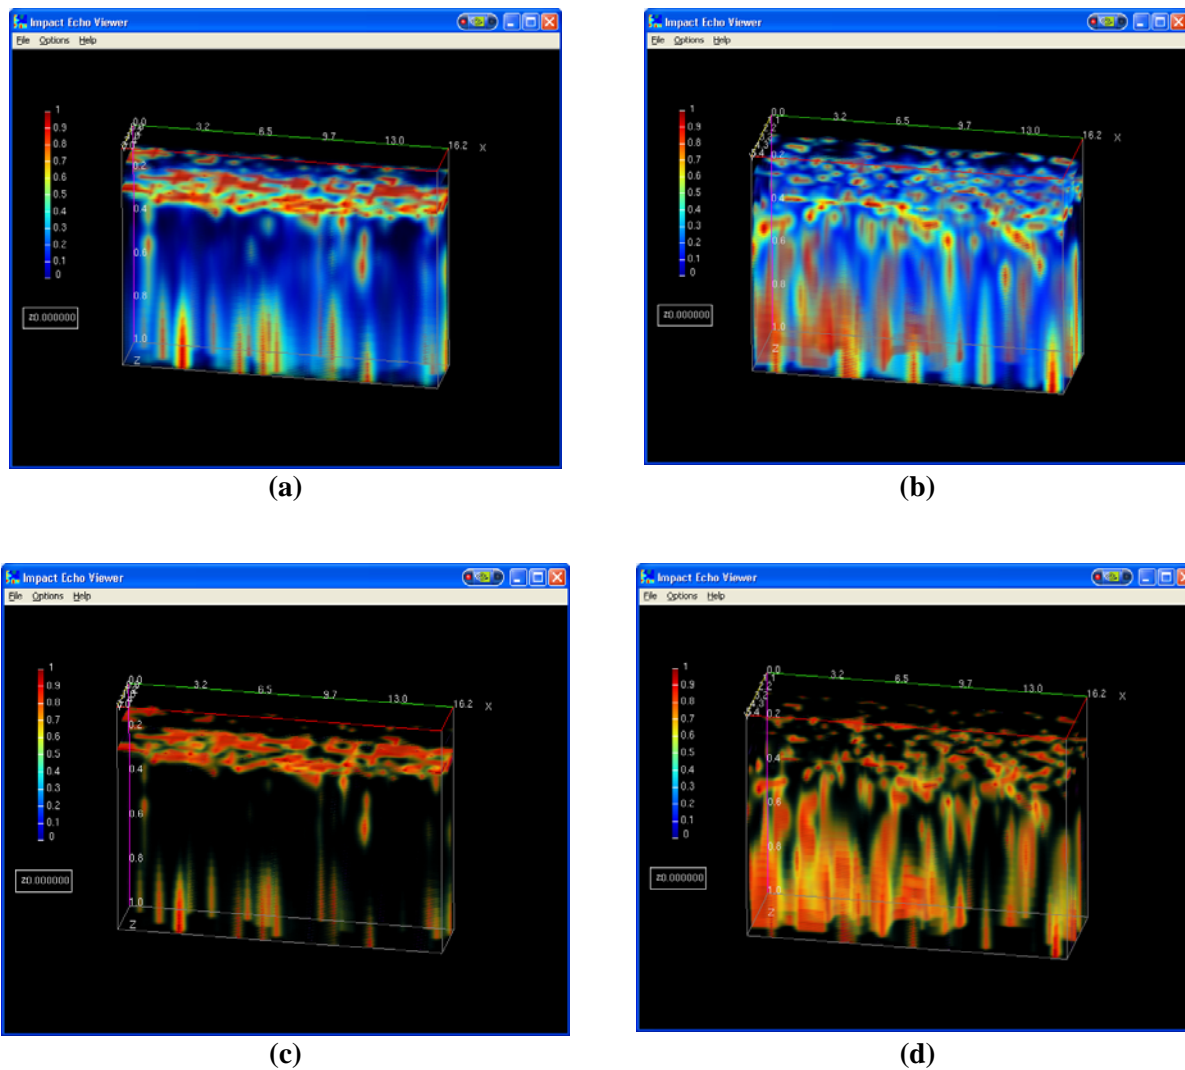
**FIGURE 6** Interactive visualization of IE data. Carter Creek Bridge (a) (c), Van Buren Bridge (b) and (d).

A 3D visualization platform for IE data was developed. The platform is written in C++ for Microsoft Windows, and depicted in Figures 6a and 6b for Carter Creek and Van Buren bridge decks. The IE data consists of a reflection value, normalized in the range [0, 1], and sampled on a discrete 3D grid of voxels. Using OpenGL, the data is rendered as a series of texture-mapped planes that slice through the volume, where the reflection strength is used as an index into a colormap look-up table that consists of red, green, blue, and alpha (transparency) values. The user can rotate and shift the camera position, enlarge or shrink the volume and observe the data from different viewing positions and angles. Additionally, as shown in Figures 6c and 6d, the user can interactively adjust the transparency so that weaker reflectors become more transparent, allowing better visualization of the strong reflectors. Similar to the observations in the previous section, in the visualizations provided in Figure 6 it can be noticed that the Carter Creek Bridge, visualized in 6a and 6c is in reasonably good condition. The primary reflections are coming from the bottom of the deck. In contrast, the Van Buren Bridge, visualized in Figures 6b and 6d, has a large number of reflections throughout the volume, indicating a highly deteriorated condition. Data presented in 3D viewer can be inspected as vertical and horizontal cross sections or slices, as illustrated in Figure 7.

Significant enhancements in IE data interpretation can be achieved by using advanced data visualization techniques. This may include presentation of data for arbitrary vertical and horizontal cross sections in terms of spectral plots, or translucent three-dimensional plots of bridge deck sections. In all cases, the ultimate objective can be described as providing a view into the internal structure of the bridge deck and assessment of structural problems. Those may include delaminations, but IE is also suitable for detecting single or multiple scattering targets (11). In the proposed bridge deck inspection framework, the IE data set is visualized in 3D space for inspection by a user.

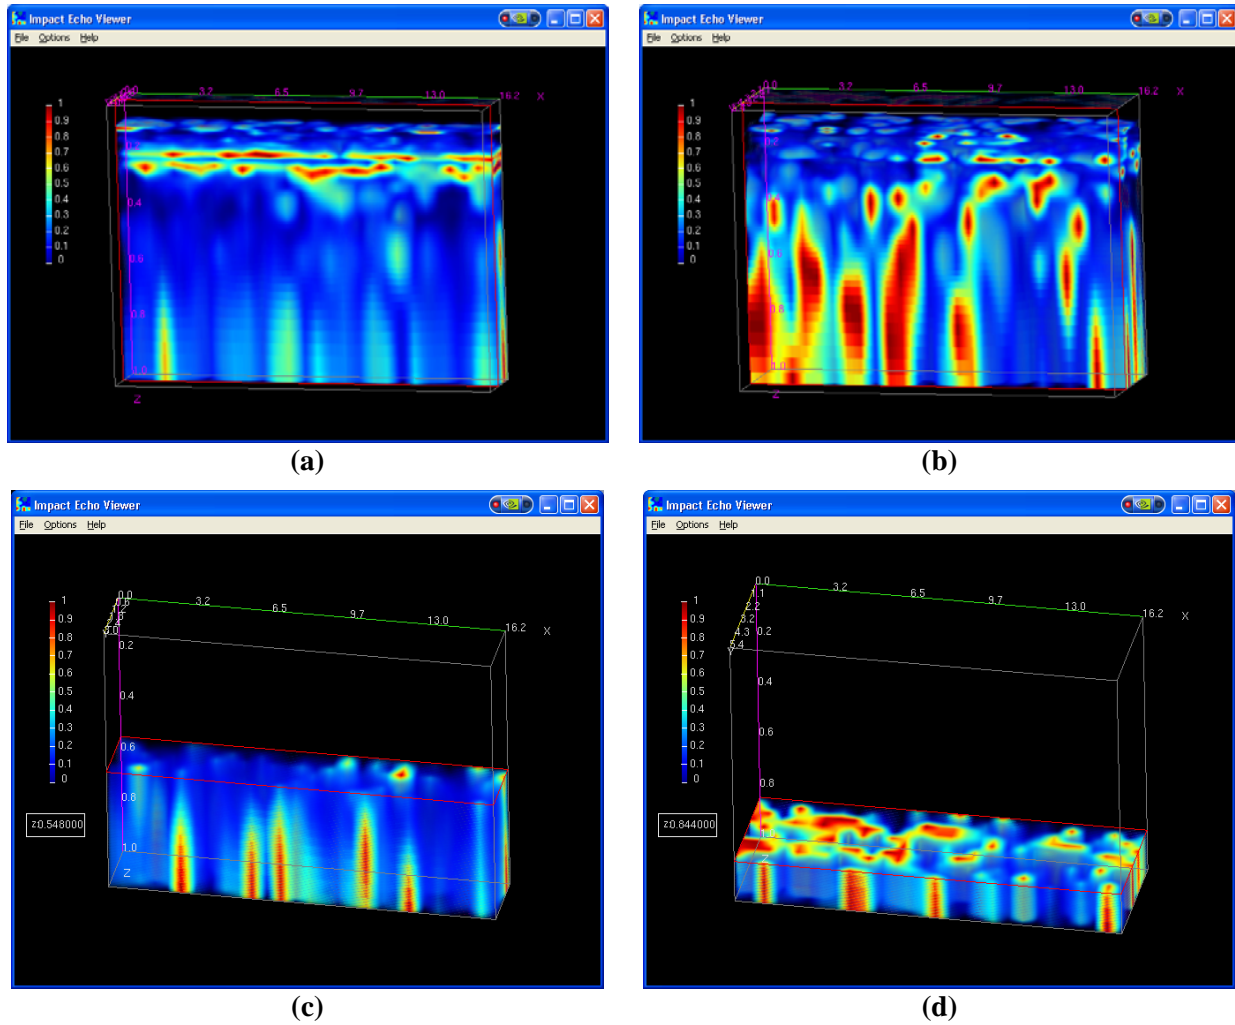
**FIGURE 7** Vertical (top row) and horizontal (bottom row) cross-sections through the data. Left: Carter Creek Bridge (vertical section for  $y=1.6$  m (a) and horizontal for  $z=0.54$  m (c)), Right: Van Buren Bridge (vertical section for  $y=3.5$  m (b) and horizontal for  $z=0.84$  m (d)).

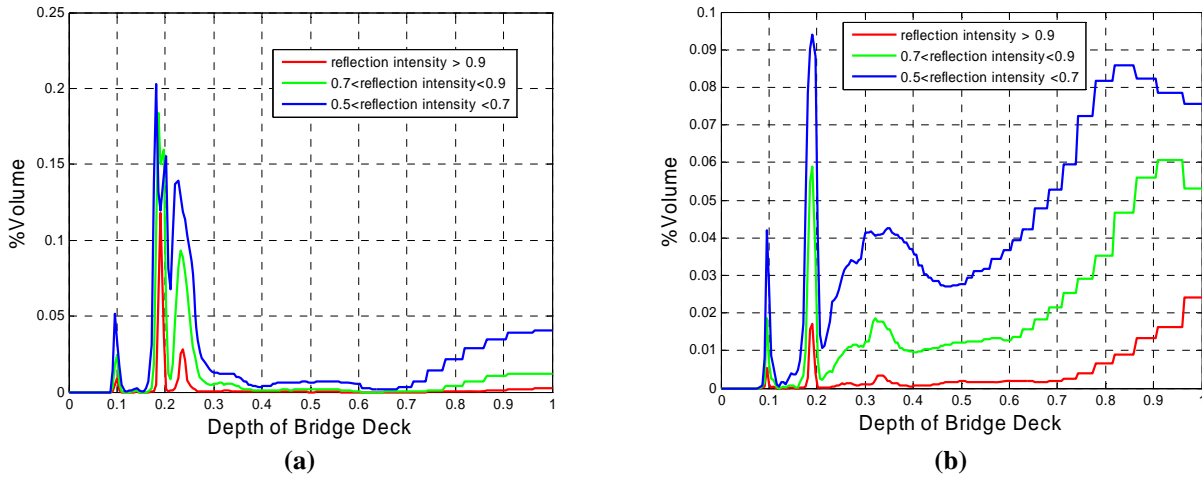
To locate the depth of the strongest reflectors, which could be indicators of defects in a bridge deck, it is very useful to study the relationship between the reflection intensity and depth of the bridge deck. In Figure 8a, strongest reflections appear around a depth equal to about 0.2 m, which corresponds to the bottom of the deck. This phenomenon indicates that the deck is in good condition, consistent with the previous observation and analysis. However, in Figure 8b, strong reflections appear throughout the deck, particularly in the lower regions (close to a 1 m depth) of the deck, indicating presence of flexural oscillations of the upper portion of the deck and thus serious condition.

**FIGURE 8** Percent Volume for Various Reflection Intensities vs. Depth. Carter Creek (a), Van Buren (b).

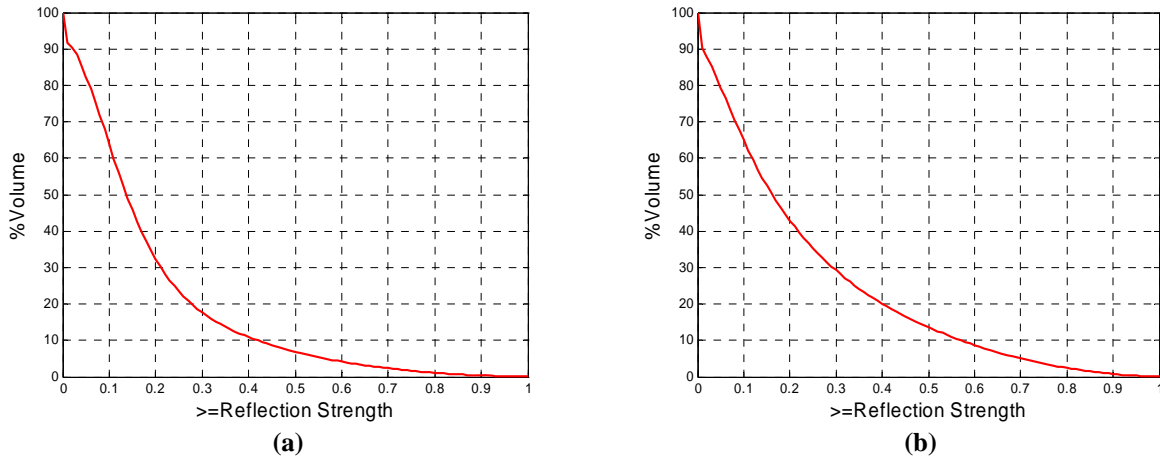
We also examined the cumulative distribution of reflection intensities, shown as Fig. 9. Specifically, these graphs plot the percentage of the IE reflectivity that is greater than or equal to a specific reflection strength. From this figure, it is obvious that strong reflectors at depths deeper than the bottom of the deck are existing in the Van Buren (b) are more than those in the Carter Creek Bridge (a). This is considered to be a sign that the former bridge deck is in a worse condition. Quantitatively, this can be presented in terms of the areas under the curve, which for Carter Creek is 1909.8 and Van Buren Bridge 2376.6.

**FIGURE 9** Cumulative Distribution of Reflection Intensity. Carter Creek Bridge (a) and Van Buren Bridge (b).

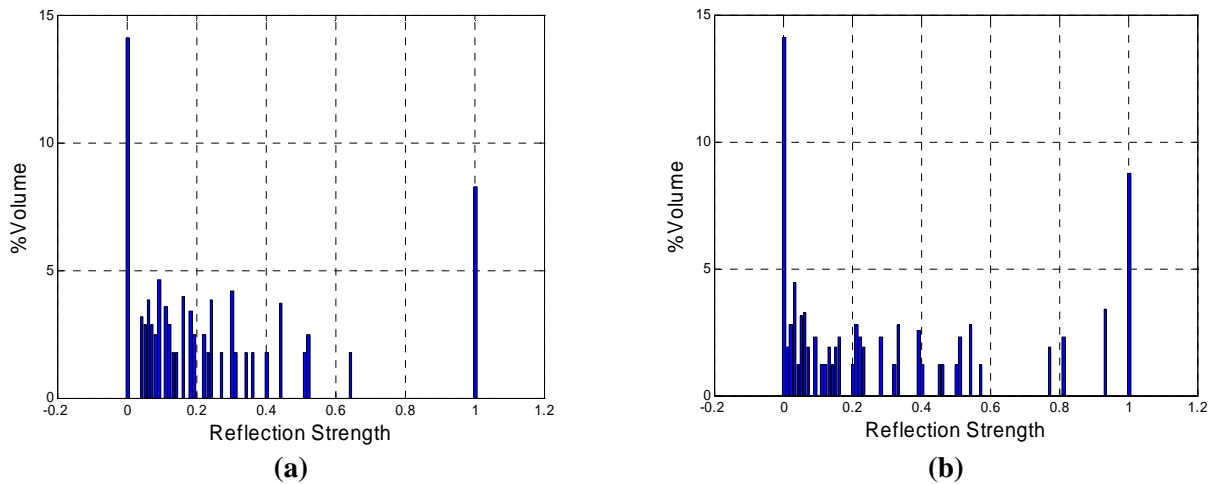
A histogram is the graphical version of a table which shows what proportion of cases fall into each of several or many specified categories. In Fig. 10, the histograms of both bridges are shown. It is worthy noting that the percentage of volume of strong reflection intensity in Carter Creek Bridge is less than Van Buren Bridge, which supports the previous analysis that the latter one is more deteriorated.

**FIGURE 10** Histogram of Reflection Intensity. Carter Creek Bridge (a), Van Buren Bridge (b).  
Log(% volume(at each reflection strength)) + constant.

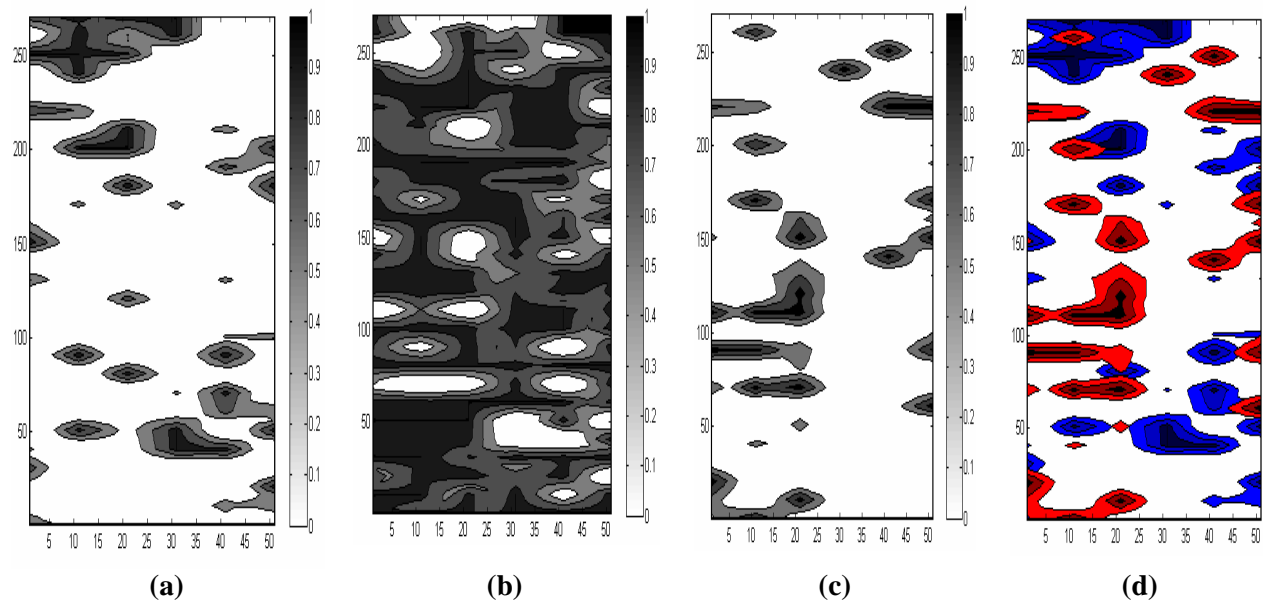
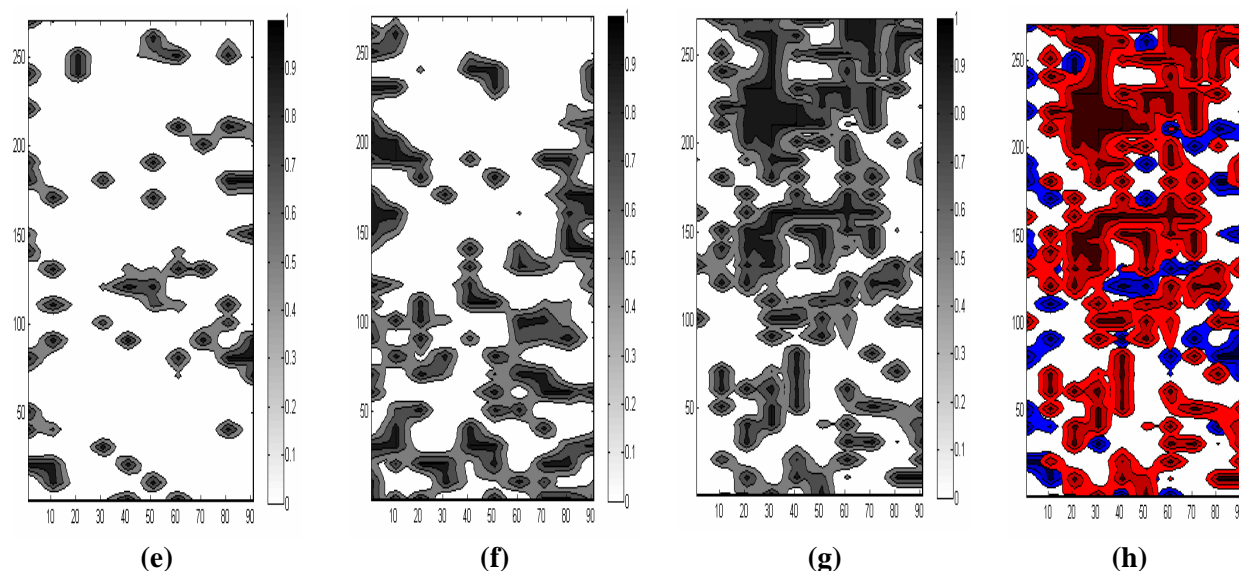
From the practical point, of highest interest and benefit is identification of zones on the deck that are in serious condition (progressed delamination) or fair to poor condition (initial delamination). The process of identification of such zones is illustrated in Figure 11. Initial delamination (fair to poor conditions) is primarily identified by medium to strong reflections at the depth corresponding to the position of the top rebars. This is illustrated in Figures 11a and 11e for Carter Creek and Van Buren bridges, respectively,

with strong reflection maps for slices between 7 and 13 cm. Similarly, sound zones of the deck are identified by strong reflections from the bottom of the deck, or in this case described by slices between 16 and 24 cm depth in Figures 11b and 11f. (Clearly, the Carter Creek Bridge deck is in a better condition.) Finally, progressed delamination (serious condition) can be described by strong reflection maps for the slice for the depth deeper than the depth of the bottom of the deck. This is illustrated by the strong reflection maps for slices between 30 cm and 1 m in Figures 11c and 11g. To obtain the map of zones candidates for repair, the map for serious condition is superimposed on the map of initial delamination, as e.g. repair map in Figure 11d is obtained from the map in Figures 11c superimposed on the map in Figure 11a. A comparison of maps for Carter Creek Bridge in Figure 11d and Van Buren Bridge in Figure 11h points clearly to significantly higher deterioration and need for repair of the latter one.

**FIGURE 11** Plan view contour plots for deck repair. Top: Carter Creek Bridge, Bottom: Van Buren Bridge. Left to right: the maximum reflectance in the “delamination zone” slice (0.07m~0.13m) (a)(e), in the “bottom of the deck” slice (0.16m~0.24m)(b)(f), and in the “apparent deep reflector” zone (0.3m~1m)(c)(g). Identified deteriorated zones (d) and (h) (red - serious condition, blue – fair to poor condition).
